Executive Summary
**Post-Wildfire Salvage Logging,
Soil Erosion, and Sediment
Delivery—Ponderosa Fire,
Battle Creek Watershed,
Northern California**

Preliminary Results

Sierra Pacific Industries
September 2014

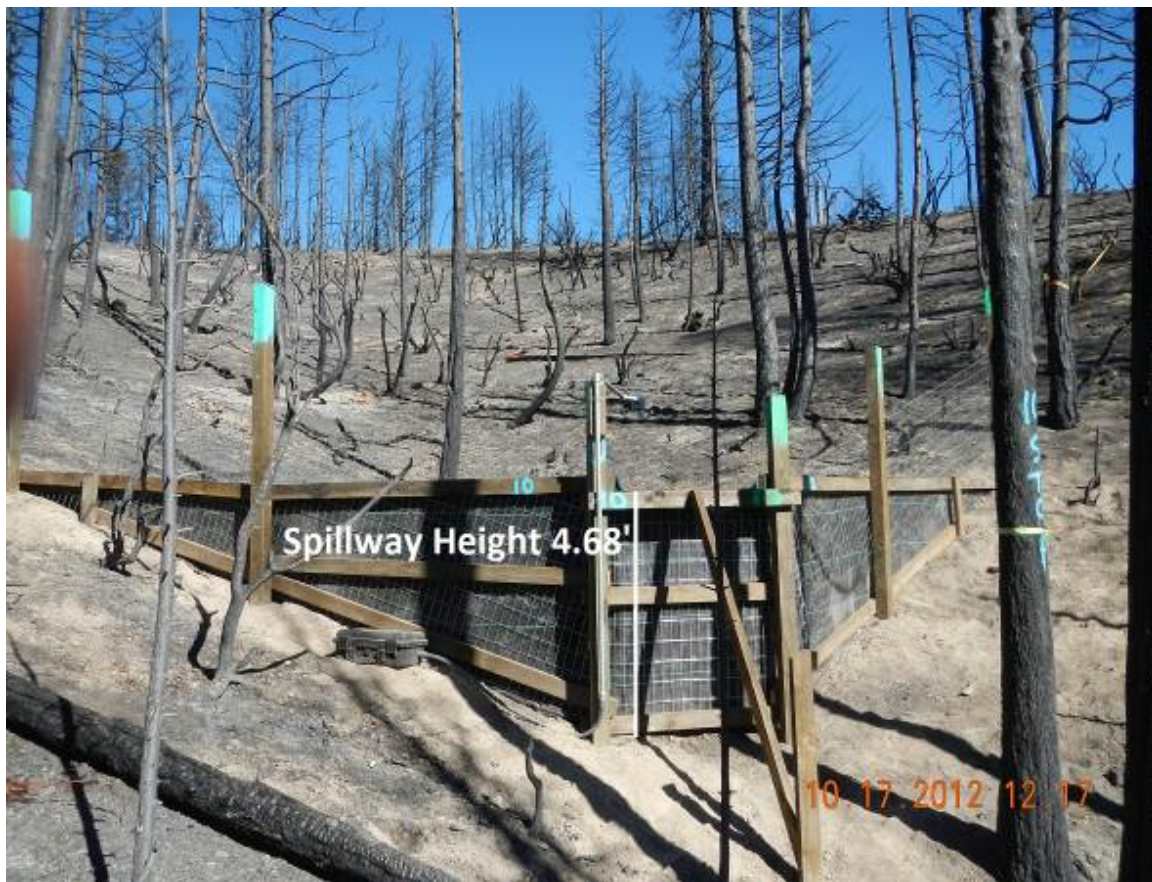
Figure ES-3. This photograph shows the upslope view at the back of a control site sediment fence. In this view both the sediment fence structure and most of the contributing swale can be seen. The spillway in the center of the fence is evident and the fence is braced with a post to counter the weight of captured sediment. Because it is a control site, this swale was not salvage-logged nor contour subsoiled and was disturbed only by the Ponderosa Fire itself. Note the relatively uniform nature of the soil surface which is covered by ash, the remnant dead trees evident throughout the burned swale and that there is no obvious stream channelization in the swale prior to the occurrence of post-wildfire rain. Although undisturbed by any post-wildfire treatment, the control sites produced the highest water runoff and average soil erosion during the over the first winter season (see Figures ES-7 and ES-8).

A weather station was established near the study area (Figure ES-2). Sediment fences were constructed at the downslope end of each site to capture and measure water and sediment (Figures ES-2 through ES-6). The top of each sediment fence had a spillway at its center to allow water to escape if it was entirely filled (Figure ES-3). Water depth sensors were placed at each fence to track and quantify the depth of the water and soil that accumulates behind the fences over time. Cameras were also placed at each fence so that 30-minute time-lapse photographs could be assembled into videos that show water filling and draining with associated sediment accumulation.

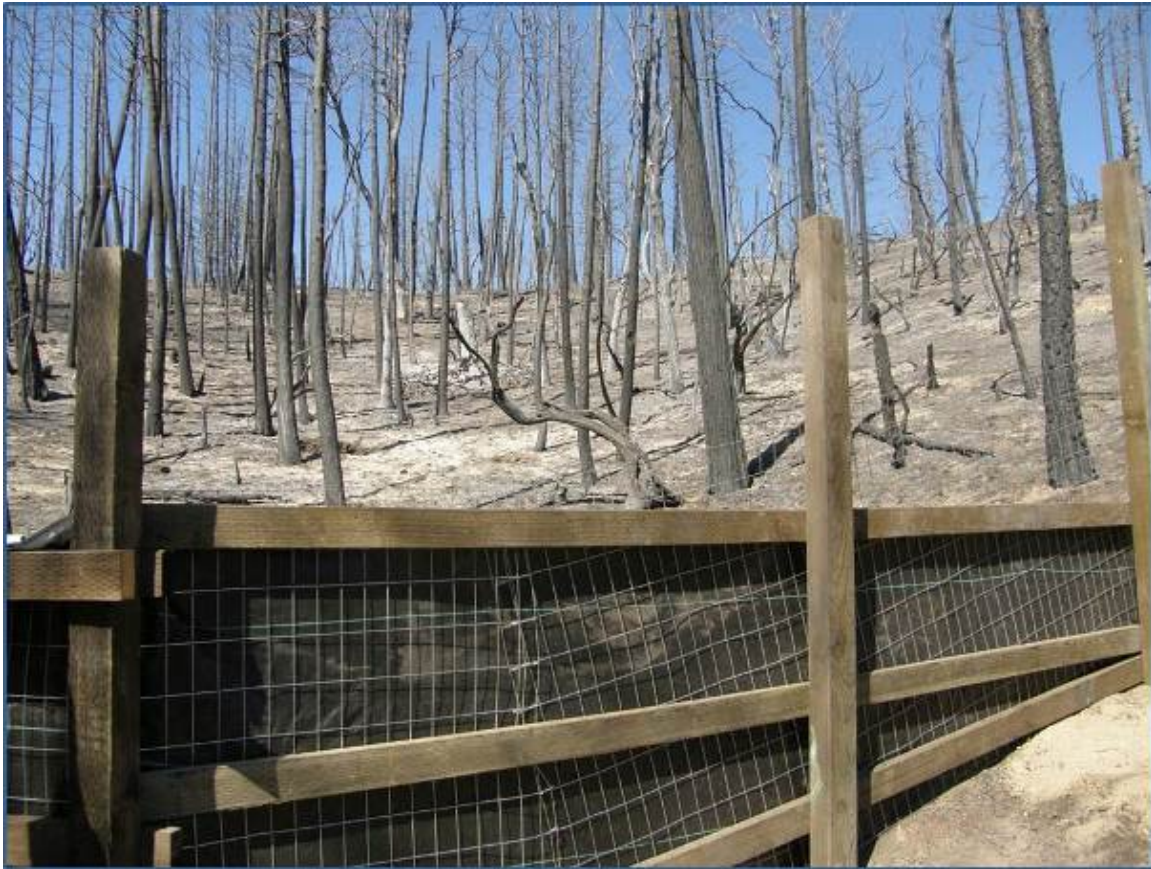
Figure ES-4. This photograph shows a closer view (compared to Figure ES-3) of a control site looking upslope from the downslope side of its sediment fence. Note the relatively uniform nature of the soil surface which is covered by ash, the remnant dead trees evident throughout the burned swale and that there is no obvious stream channelization in the swale prior to the occurrence of post-wildfire rain. Because it is a control site, the swale was not salvage-logged nor contour subsoiled and was disturbed only by the Ponderosa Fire itself. Although undisturbed by any post-wildfire treatment, the control sites produced the highest water runoff and average soil erosion over the first winter season (see Figures ES-7 and ES-8).

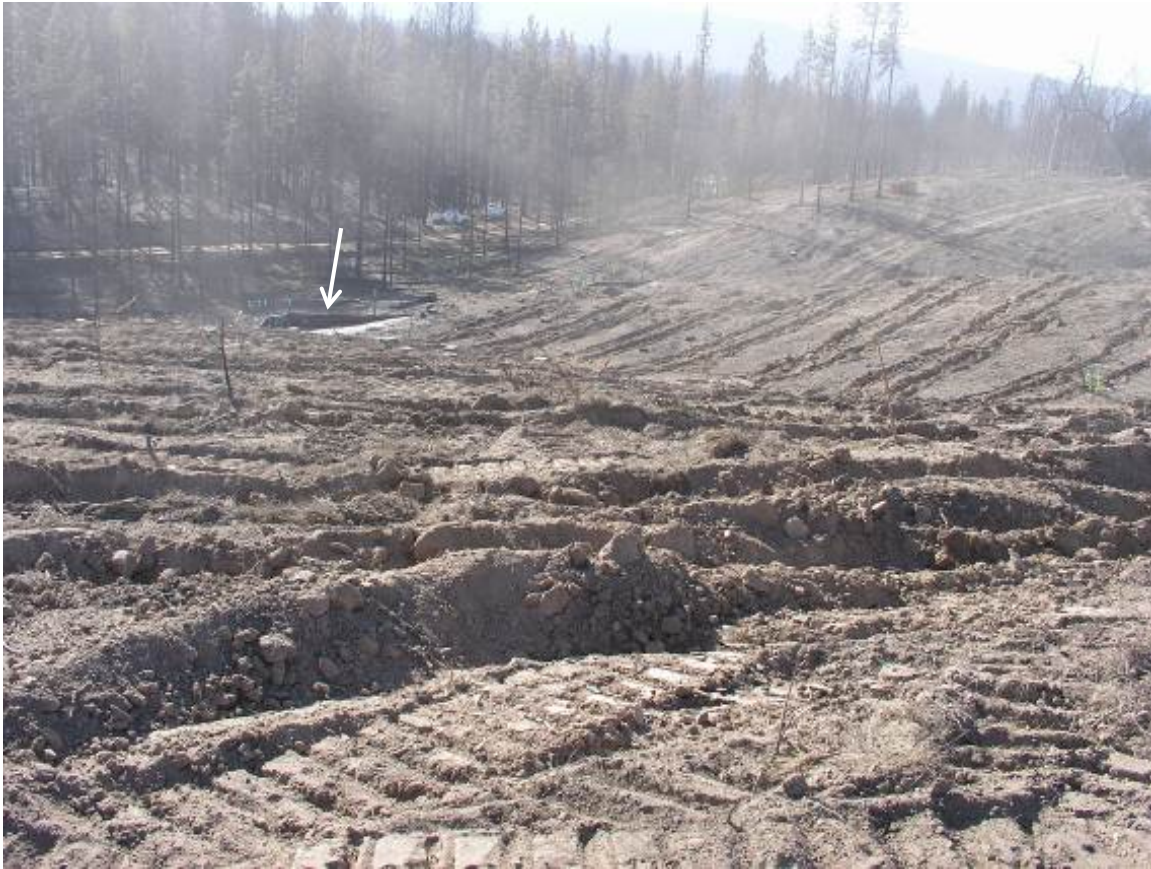
Figure ES-5. This photograph shows the downslope view from near the top of a swale treated with salvage logging plus biomass removal and contour subsoiling. The sediment fence is visible towards the upper left of the photograph (white arrow). The approximately 20-inch-deep furrows created by the subsoiling and the loose soil piled along their sides are evident throughout the swale. The furrows are oriented on contour with the slope or perpendicular to the downslope swale direction and interrupt water and sediment movement down the swale center. Note that the furrow orientation is not contour parallel on the contributing slopes. This combination of treatments produces the most site disturbance. Despite this visually stark and high level of disturbance, sites receiving these treatments produced substantially *less* water runoff and average soil erosion over the first winter season compared to the control sites (see Figures ES-7 and ES-8).

After harvesting contour subsoiling was applied to four of the salvaged logged sites (two of which received salvage logging, two of which received salvage logging plus biomass removal); this ground-based treatment helps prepare the land for subsequent replanting. These four sites were mechanically subsoiled on contour using a D-6 tractor that created furrows at 7- to 10-foot intervals to a depth of approximately 20 inches.

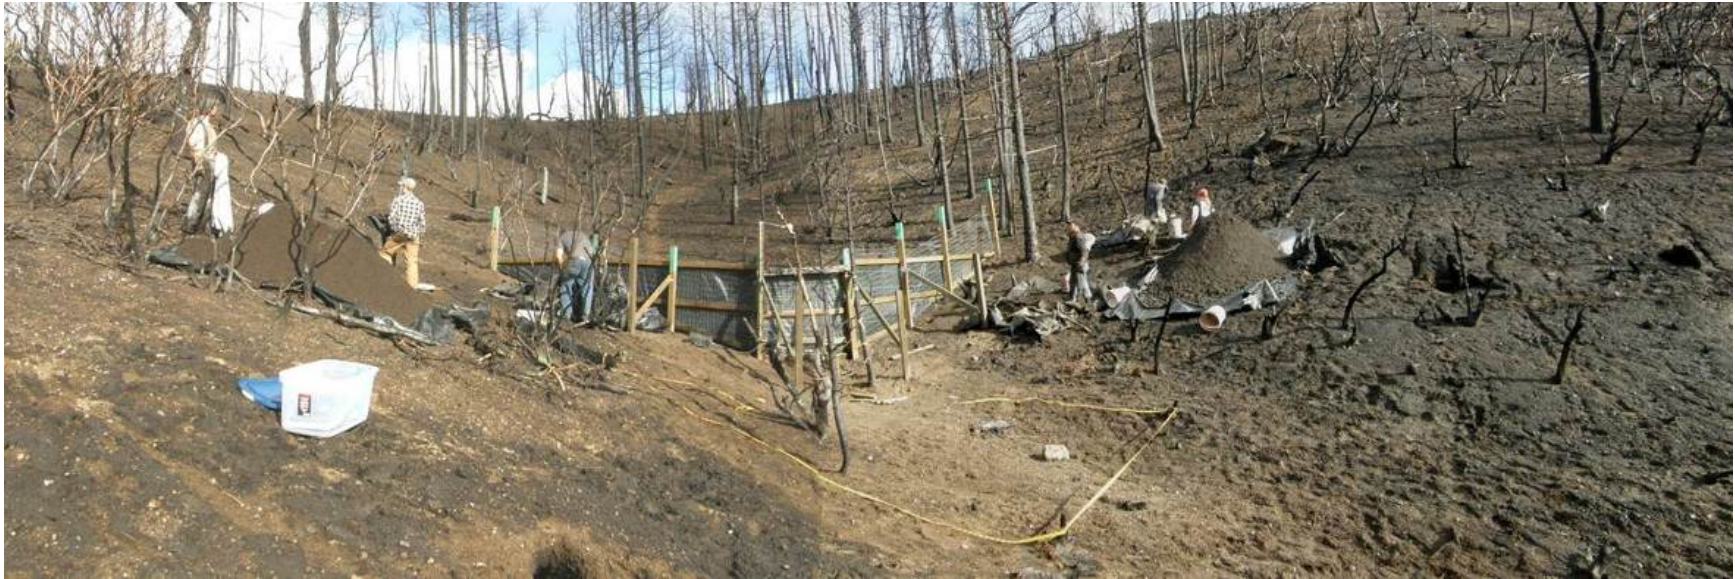
Figure ES-6. This photograph is looking upslope during a sediment fence cleanout of a control site. Note the people for scale. Sediment has been removed from within the sediment fence, weighed, and then piled on the sides and downslope of the sediment fence. As a control site, this swale received no salvage logging nor contour subsoiling. Note that on the control sites rill erosion features began forming on the burned hill slopes immediately after rainfall events. At this control site a main channel has begun to form; it shows as the lighter brown streak extending uphill from the fence through the middle of the swale. The sediment pictured accumulated during the first 3 months following fire containment.

Accumulated sediment was removed by hand crews using shovels and buckets. Wet and dry weight as well as organic matter content was determined (Figure ES-6). In summer 2014, field topographic surveys were conducted to map and characterize the size, shape, and position of rills that developed over WY 2013.

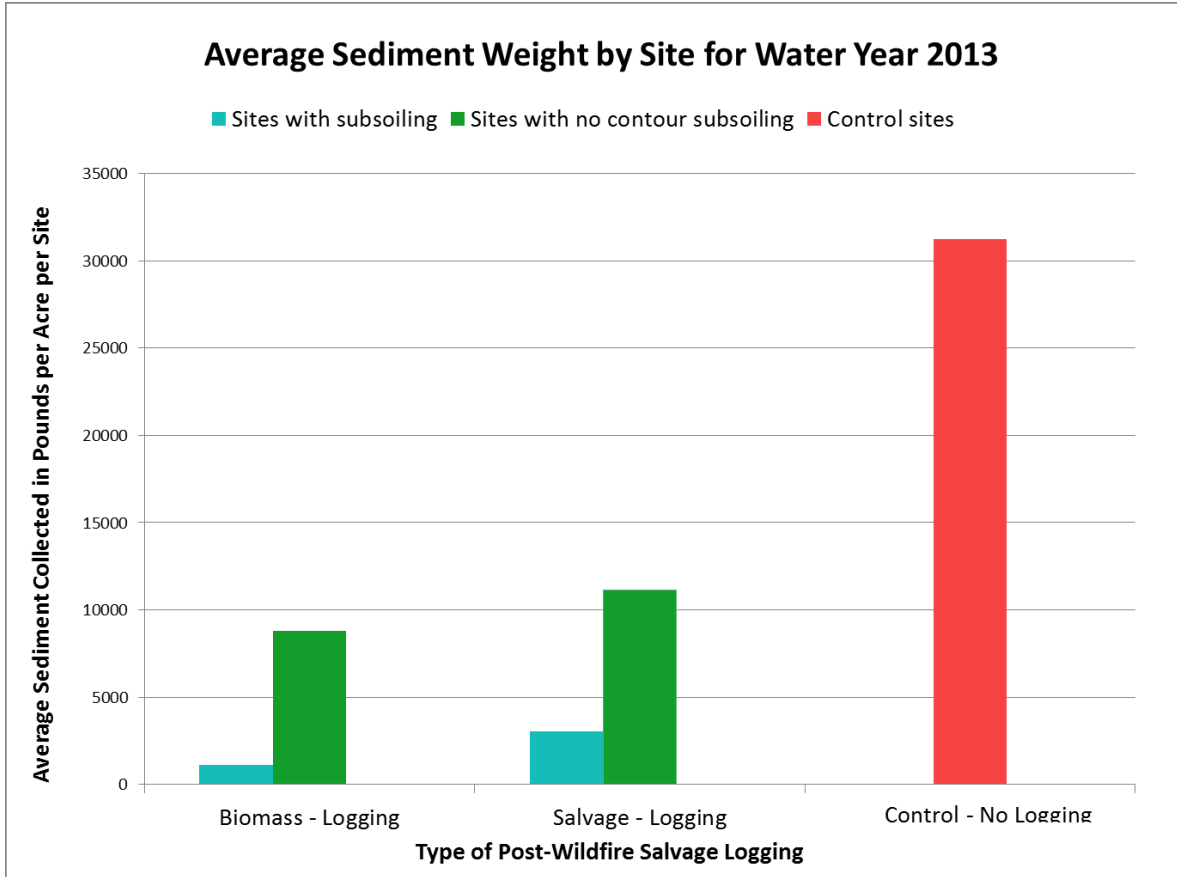
Figure ES-7. This bar chart shows the results of the first winter season average sediment weight (pounds per acre) for the controls and the treatment groups. Although undisturbed except for the Ponderosa Fire, the control sites (the red bar labelled Control—No Logging) showed the most soil erosion, producing an average of more than 30,000 pounds of sediment per acre. The sites with treatments having the most disturbances—salvage logging and contour subsoiling, with or without biomass removal—had the least amount of soil erosion (the light blue bars). Specifically, salvage logging plus biomass removal *combined* with contour subsoiling produced an average of approximately 1,000 pounds of sediment per acre. Salvage logging *without* biomass removal but *with* contour subsoiling produced an average of approximately 4,000 pounds of sediment per acre. Salvage logging *without* contour subsoiling produced an intermediate amount of soil erosion, averaging approximately 8,000 pounds and 11,000 pounds of sediment per acre, with and without biomass removal, respectively.

Erosion results for WY 2013 show that immediately following the fire, the control sites by far produced more sediment than the salvage-logged sites (Figure ES-7). Overall the control sites averaged greater than 30,000 pounds of sediment per acre. By contrast, the sites treated with salvage logging and contour subsoiling produced the least amount of sediment, averaging 1,000 pounds and 4,000 pounds per acre, with and without biomass removal, respectively. The sites treated with salvage logging without contour subsoiling produced an intermediate amount of sediment, averaging 8,000 pounds and 11,000 pounds per acre, with and without biomass removal, respectively.
